RESERVE STUDY

Update w/o Site Visit Review

Green Valley Recreation Inc

2024 Update- Includes DSC- 3

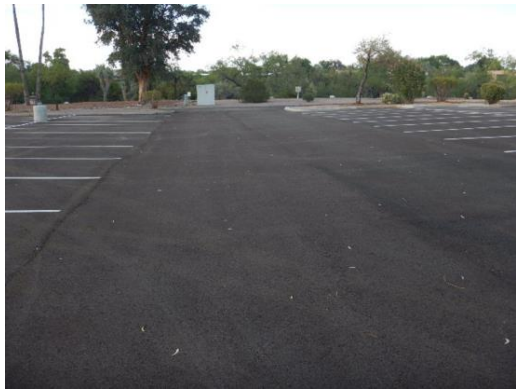
This is to prepare the surface and apply a single coat asphalt emulsion product. If a second coat is desired, the cost is generally 10% to 20% higher.

2024- After repaving in 2024, the sealing may still need to be done.

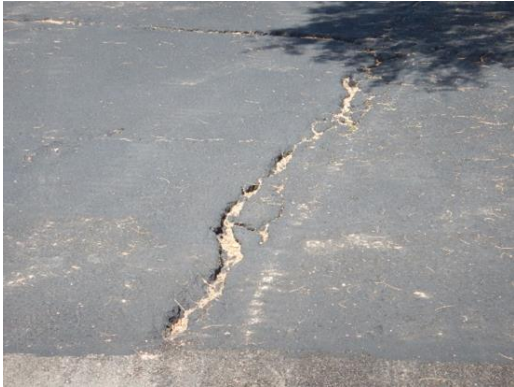
Moderate cracking noticed in a few areas.

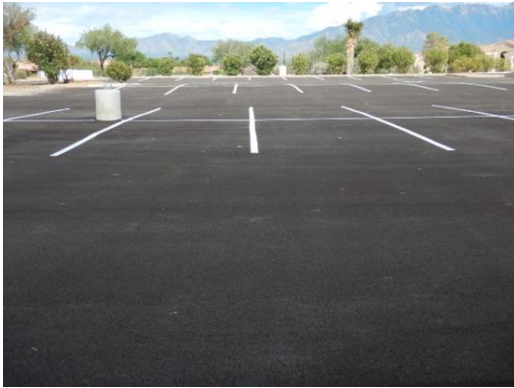
300 - Asphalt: Overlay w/ Interlayer 63,350 sf Parking, Driveway	Useful Life 25 Remaining Life 25 Quantity 63,350 Unit of Measure Square Feet Cost /SqFt \$3.00 % Included 100.00% Total Cost/Study \$190,050
Summary	Replacement Year 2049 Future Cost \$352,342

This is to apply a geotextile interlayer to the existing asphalt surface and overlay with a minimum of 1.5" of new hot mix asphalt. Generally this includes edge grinding and utility box extensions.

2024- Based on the rehab in 2024, the remaining life has been set to full in 2024. Per client, the work done in 2024 was estimated at \$154,000.

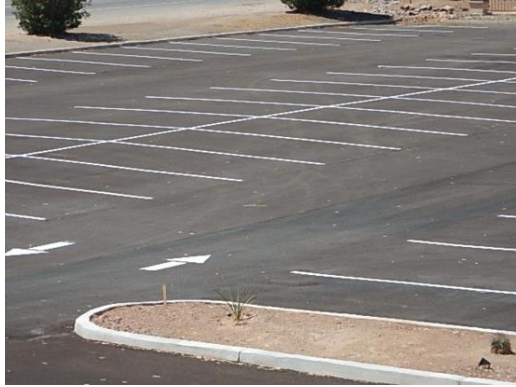
This is to re-stripe asphalt to match existing plan.

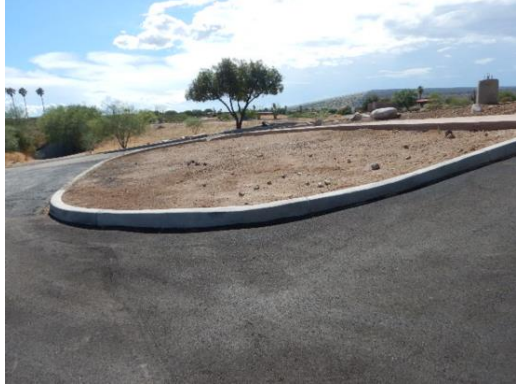
210 - Curbs & Gutters	Useful Life 5	Remaining Life 5
1,976 lf Curbing Along Asphalt Perimeter (4%)	Quantity 1,976	Unit of Measure Linear Feet
	Cost /l.f. \$32.00	Qty * \$/l.f. \$63,232
	% Included 4.00%	Total Cost/Study \$2,529
Summary	Replacement Year 2029	Future Cost \$2,862

This is to replace the gutter curbing along the roadway perimeter.

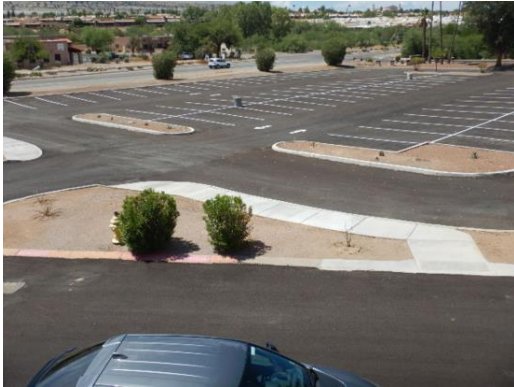
This includes the walks at the striped parking areas, clubhouse entry and loading areas at rear, and landing apron from second floor.

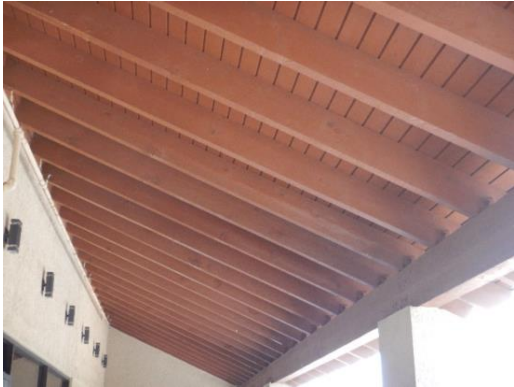
120 - Surface Restoration	Useful Life 10	Remaining Life 10	
Clubhouse Exterior Elements	Quantity 1	Unit of Measure Lump Sum	
	Cost /LS \$19,000		
	% Included 100.00%	Total Cost/Study \$19,000	
Summary	Replacement Year 2034	Future Cost \$24,322

This is to prepare, power wash, sand, scrape, caulk and paint, with an appropriate product for the surfaces impacted. This includes stucco, wood trim, metal, railings, door and window trim and soffits.

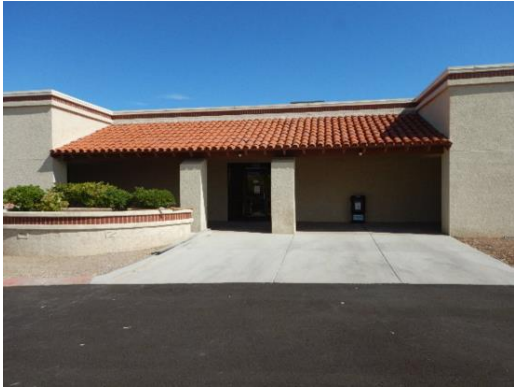
140 - Mid Cycle Touch-Up	Useful Life 10	Remaining Life 5
Clubhouse Exterior Elements	Quantity 1	Unit of Measure Lump Sum
	Cost /LS \$6,000	
	% Included 100.00%	Total Cost/Study \$6,000
Summary	Replacement Year 2029	Future Cost \$6,788

This is to perform touchup painting midway between full painting cycles. Mid cycle painting is typically necessary with long duration full paint cycles.

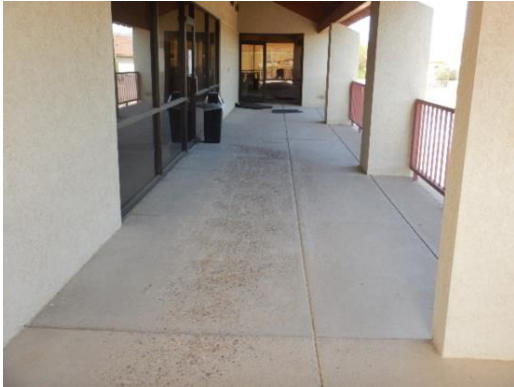
Picture of degraded concrete walk at balcony.

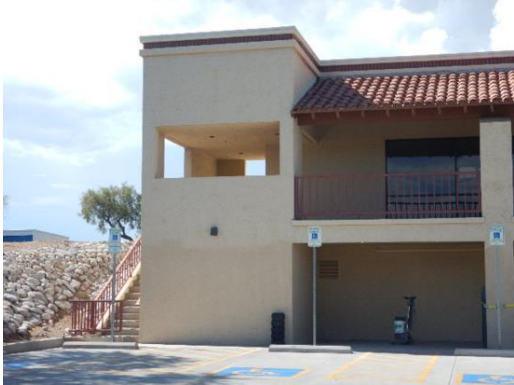
510 - Railing: Metal	Useful Life 30	Remaining Life 20
180 lf Building Exteriors	Quantity 180	Unit of Measure Linear Feet
	Cost /l.f. \$80.00	
	% Included 100.00%	Total Cost/Study \$14,400
Summary	Replacement Year 2044	Future Cost \$23,596

This is to repair and replace the railings at the stairs and the rear balcony.

Two railings are visible at the stairs and at the balcony.

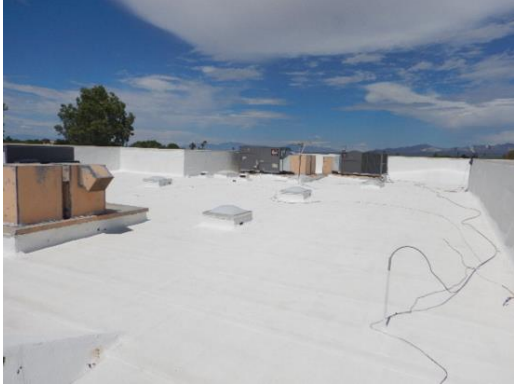
This is to replace the low slope single-ply vinyl roofing system. All roofs should be regularly inspected and repaired as indicated to ensure maximum life.

This include the parapet walls.

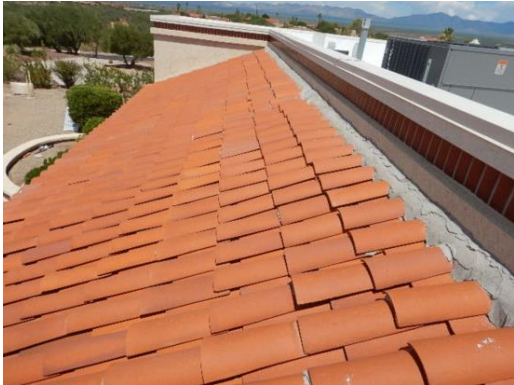
620 - Pitched: Spanish Tile	Useful Life 30	Remaining Life 25	
12 Squares- Clubhouse	Quantity 12	Unit of Measure	Squares
	Cost /Sqrs \$1,100		
	% Included 100.00%	Total Cost/Study	\$13,200
Summary	Replacement Year 2049	Future Cost	\$24,472

This is to replace the tile roofing system. Tile roofs should be regularly inspected and repaired as indicated to ensure maximum life.

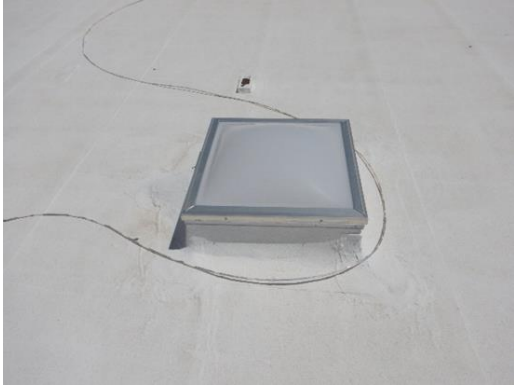
This is to replace the skylights. There are seven of various sizes.

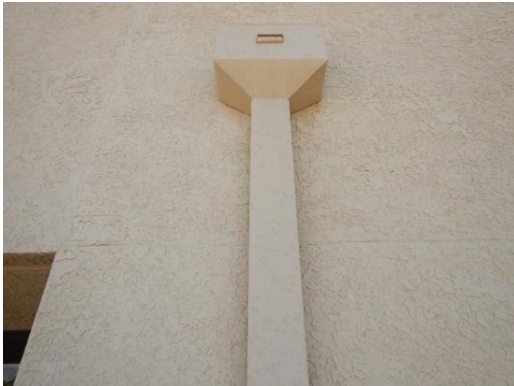
910 - Gutter Cleaning	Useful Life 20	Remaining Life 20	
Scuppers	Quantity 1	Unit of Measure	Lump Sum
	Cost /LS \$4,000		
	% Included 100.00%	Total Cost/Study	\$4,000
Summary	Replacement Year 2044	Future Cost	\$6,554

This is to clean the gutters and downspouts and scuppers.

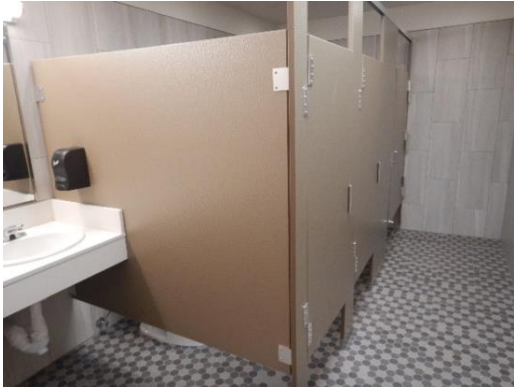
This includes all elements not in other categories:

- 2- Urinals, auto-flush models
- 4- Toilets
- 2- 2 counters, with double sinks
- 10- Can lights & 4 wall lites
- 2- Entry doors
- Towel, soap, trash, mirrors, grab bars, signage

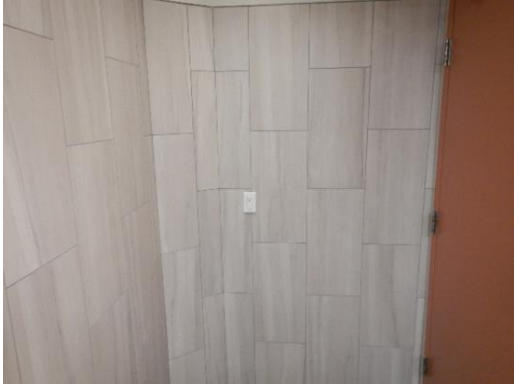
This is for replacing the wall tile per existing. Replacement costs will depend on the scope of work at replacement. This should be scheduled with the tile flooring.

This is for the double restroom area at the main building entry. Large format wall tile.

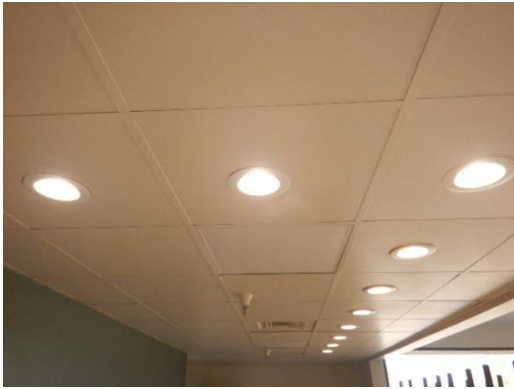
This is for replacing suspended T-Bar ceilings including the acoustic tiles.

This is the ceiling in the counter and dining areas. These appear food grade for food service and ease of cleaning.

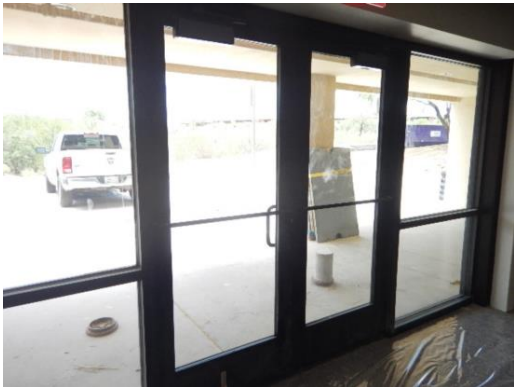
This is for a general rehab of the various doors at the project. During the 2024 site review, many areas were under construction. This is a partial replacement for flexibility for replacement.

- 3- 36" Exterior commercial storefront door sets
- 1- 36" Exterior glass door with push bar and access system (entry)
- 2- Metal 36" doors for utility
- 2- Blue indoor metal doors

2024- During the inspection these areas were under construction. The inventory can be finalized in 2025.

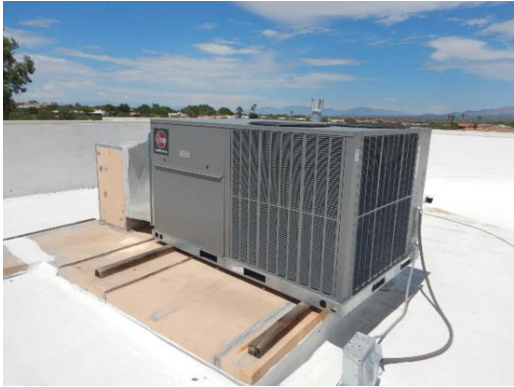
These are on the clubhouse roof.
 Rheem Model: RGEDZR090ACB152AA; Ser #: F082100056 7.5 Ton Feb. 2021 Mfg.
 Rheem Model: RGEDZR090ACB152AA; Ser #: F082100062 7.5 Ton Feb. 2021 Mfg.

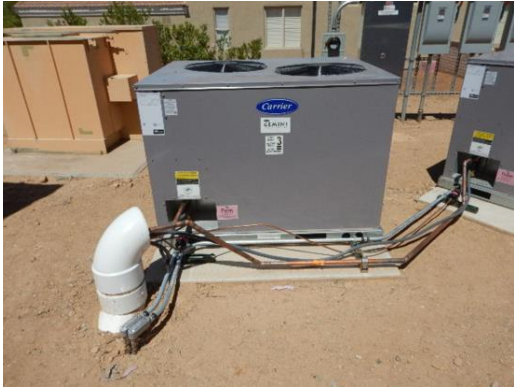
These are on the clubhouse roof.
 Carrier Gemini Split-System

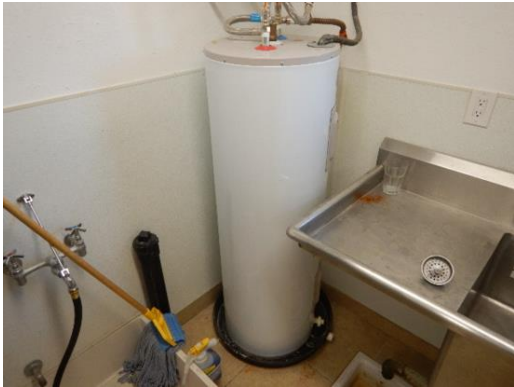
This is to replace the water heater including discarded unit disposal.

1- General Electric Model, 50 US gallons

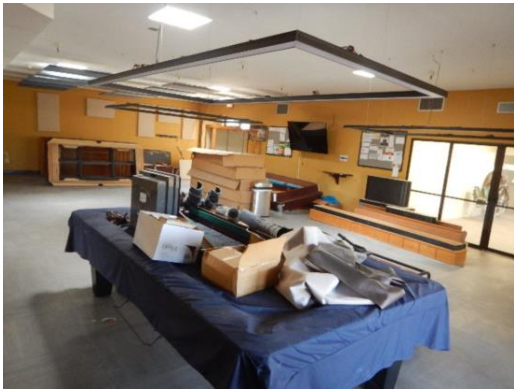
This is to replace the television at the dining room and the TV in the card room.

Card room TV in background.

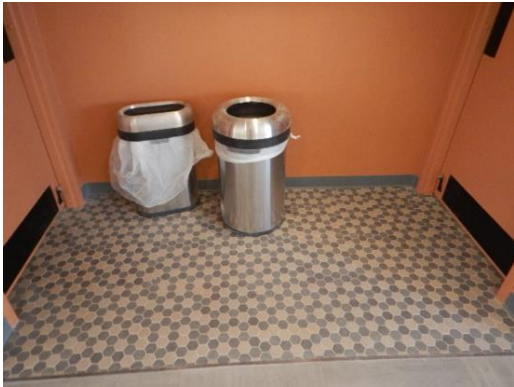
This is to replace the tile flooring.

2024- New in 2024. Small format decorative tile.

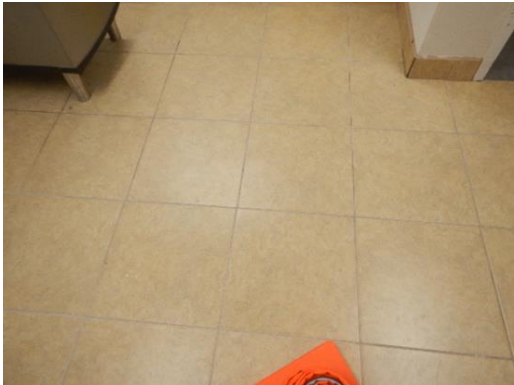
This is to replace the tile flooring at the kitchen, back of house areas.

Kitchen- 212 sq ft (old beige tile large format)
 Store room- 92 sq ft (new gray tile, large 2'x2' format)

2024- Mix of new and old tile in these spaces. Using an average life of 25 years with 15 remaining.

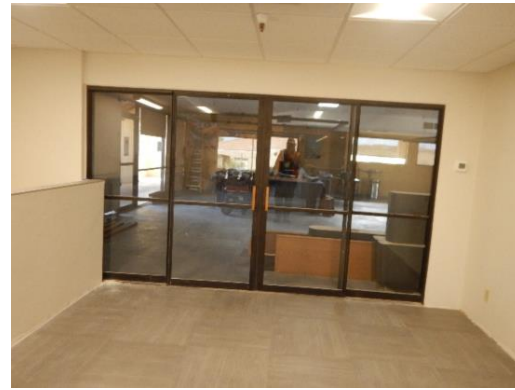
2024- All new tile in 2024.

Side room to stairs (left) to lower level.

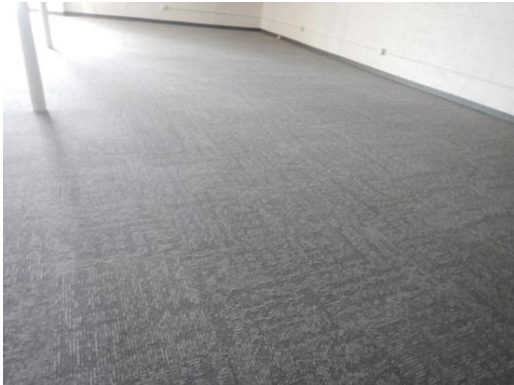
520 - Carpeting	Useful Life 15	Remaining Life 15
4,140 sf Lower Level Room	Quantity 4,140	Unit of Measure Square Feet
	Cost /SqFt \$6.00	
	% Included 100.00%	Total Cost/Study \$24,840
Summary	Replacement Year 2039	Future Cost \$35,976

This is to replace the carpet squares in the lower level. The carpet squares provide flexibility for extending the life of this component. 12" sq carpet tiles.

2024- Under construction during site visit. Carpet squares were being installed on day of visit.

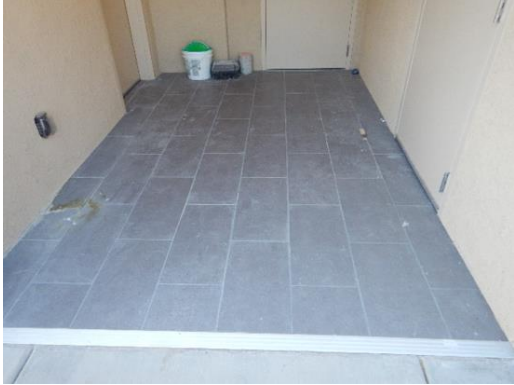
This is to replace the tile flooring at the lower level back entrance near the outside restroom. As an exterior item, the life is shorter than the interior tile.

2024- Under construction during site visit. All finishes are new.

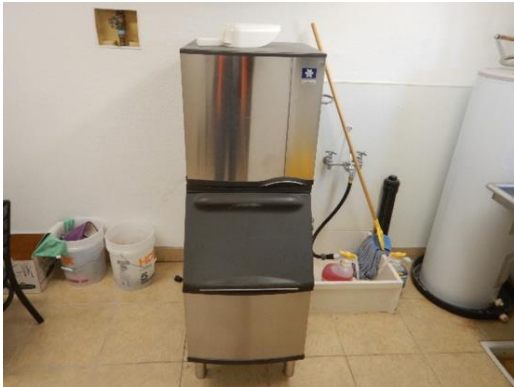
This is to replace the commercial ice machine.

Manitowac Model: B320; Ser#: 110968608

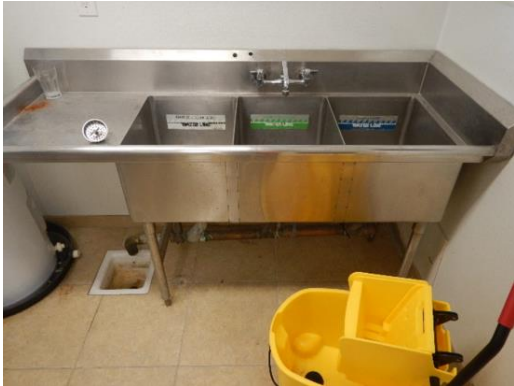
This is for the commercial grade stainless steel counter and three bay sink dishwashing station.

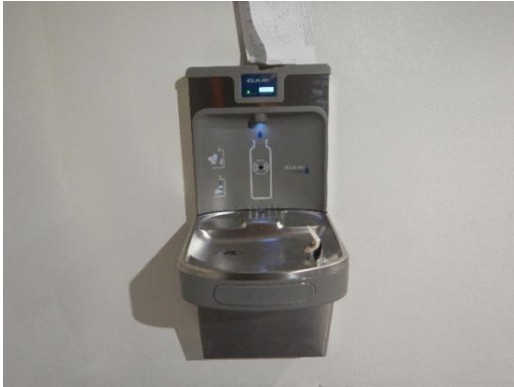
Elkay With bottle fill. Model: EZ H2O, LZS8WSSP; Ser#: 4310200982

2024- New in 2024.

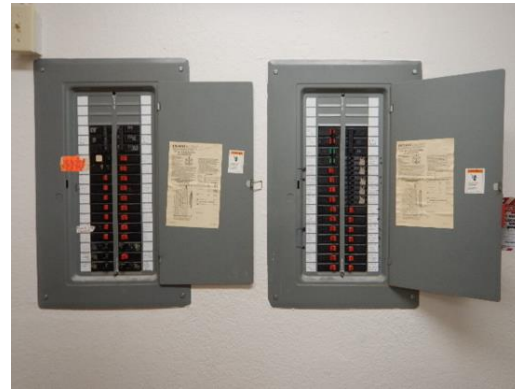
2024- The "Bryant" electric panel may not have been replaced with the remodel. This may need to be replaced as the conditions warrant and should be evaluated routinely.
